**Docket No. 217 – Development and Management Plan Inspection**

Northeast Utilities Service Company Certificate of Environmental Compatibility and Public Need for the construction of a 345-kV electric transmission line and reconstruction of an existing 115-kV electric transmission line between Connecticut Light and Power Company's Plumtree Substation in Bethel, through the towns of Redding, Weston, and Wilton, and to the Norwalk Substation in Norwalk, Connecticut.

**Date:** March 29 and 31, 2006

**Location:** Transition Stations: Hoyts Hill, Archers Lane, Norwalk Junction

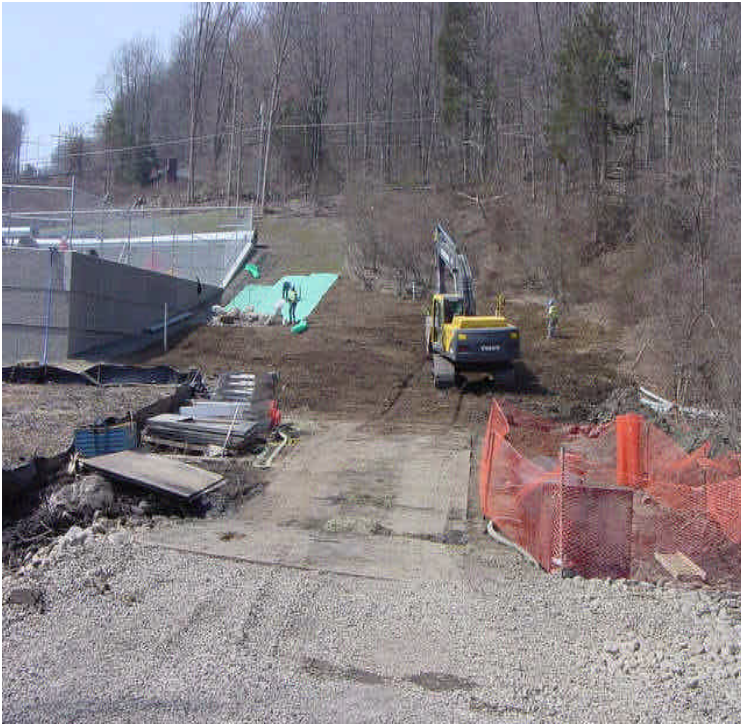
Areas of Inspection	Observation	Recommended Action	Corrected Actions
Erosion and Sediment Controls continued	<p>- It appears the erosive gullies on the northern slope of the station were filled in and repaired. 3/23/06. The crews were conducting the final grading activities and installing jute mesh at the northern slope at the time of inspection. 3/31/06.</p> <p>-The southern gully and less severe erosion along the face of the southern silt fence still needs attention. 1/26-3/31/06.</p> <p>- The majority of the sand pile stored in the driveway across from Rt. 58 was removed. 3/31/06.</p>	<p>-Continue to monitor the northern slope as it does not appear the outlet pad was changed. 3/2-3/31/06.</p> <p>-Plan to repair/stabilize the southern slope as well. 3/31/06.</p> <p>- None at this time. 3/31/06</p>	<p>Repairs were made to the gullied/eroded areas to the north of the station walls. 3/23/06. The slope was brought to final grade and jute netting was installed here 3/31/06.</p> <p>- The sand pile was removed as recommended.</p>

**Hoyts Hill Transition Station: Photo on the left shows final grading activities and erosion control mat installation on the northern slope. Photo on the right shows a view of the work continuing on the station pad. 3/31/06**

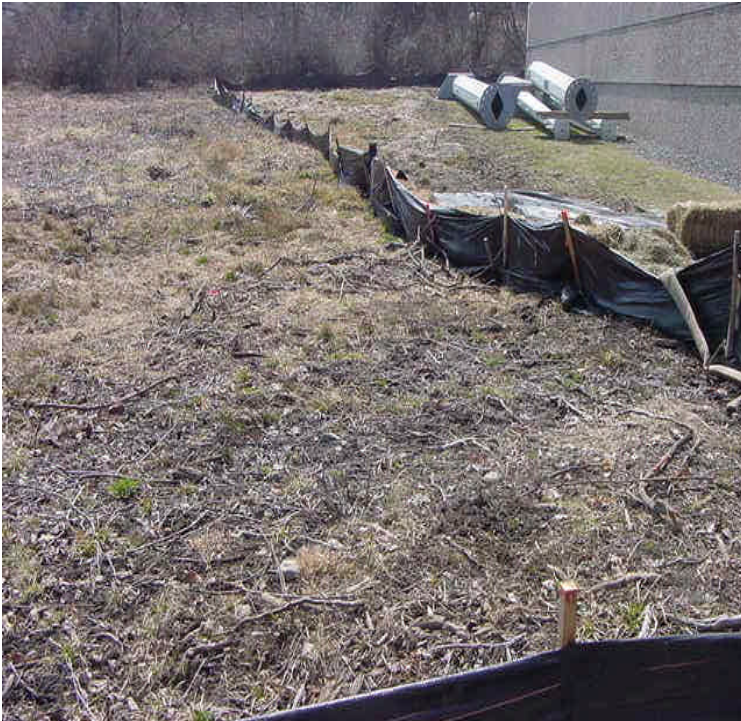
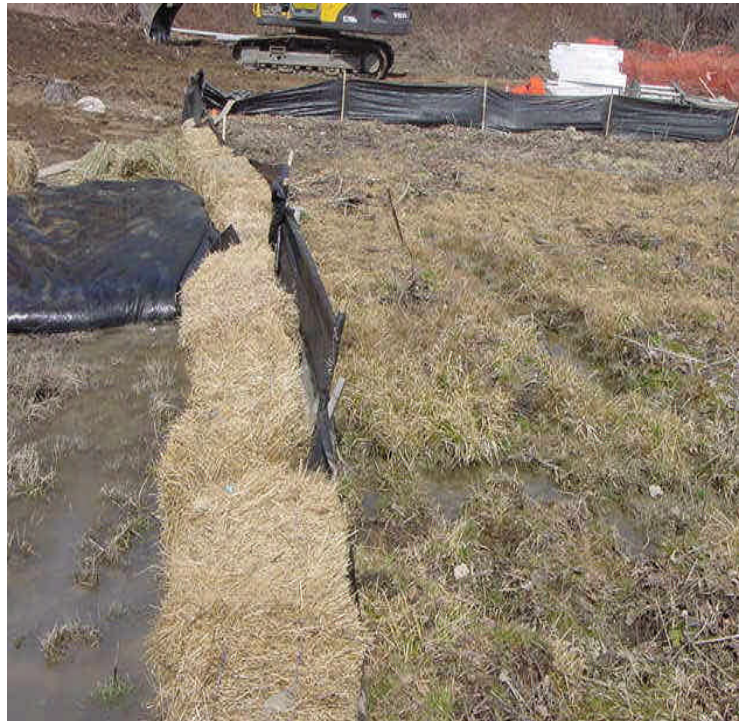
Erosion and Sediment Controls	<p>-<b>Hoyts Hill:</b> The perimeter silt fence along the wetlands at the rear of the station has been repaired well. 3/31/06.</p> <p>- Previously accumulated sediment was removed carefully from the wetland and adjacent to the silt fence. 3/31/06.</p>	<p>-Monitor and maintain the fence as necessary. 3/31/06.</p> <p>-Continue to monitor this area until slopes have stabilized and dewatering has ceased. 3/31/06.</p>	<p>- The perimeter silt fence was repaired and controls were very good.</p> <p>-Sediment was removed from the wetland, beyond the silt fence.</p>

**Both photos show the perimeter silt fence and controls installed for 345kV XLPE dewatering on site. Erosion controls have been repaired in this area and sediment removed carefully from beyond the silt fence. 3/31/06.**

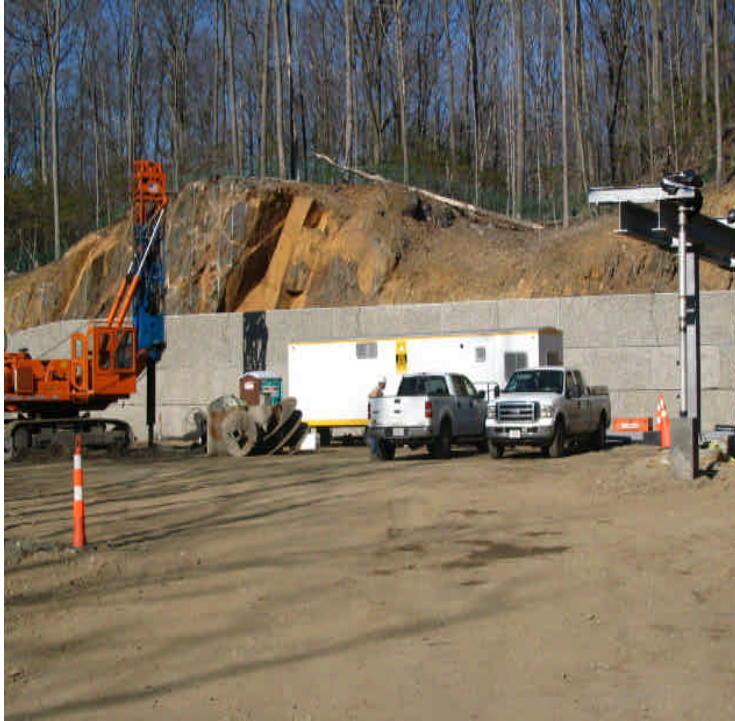
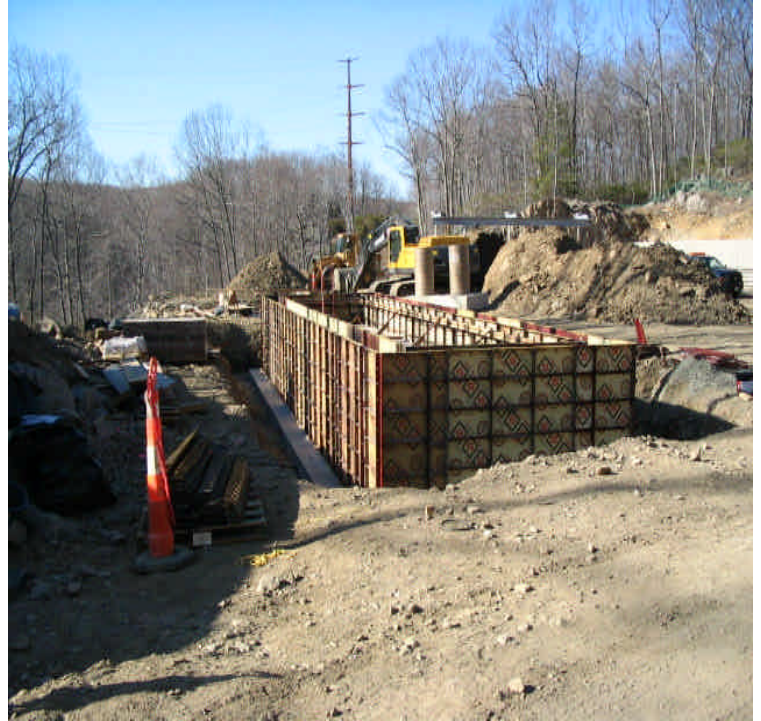
**Archers Lane Transition Station: Both photos show an overview of the work continuing within the station pad.  
3/29/06.**

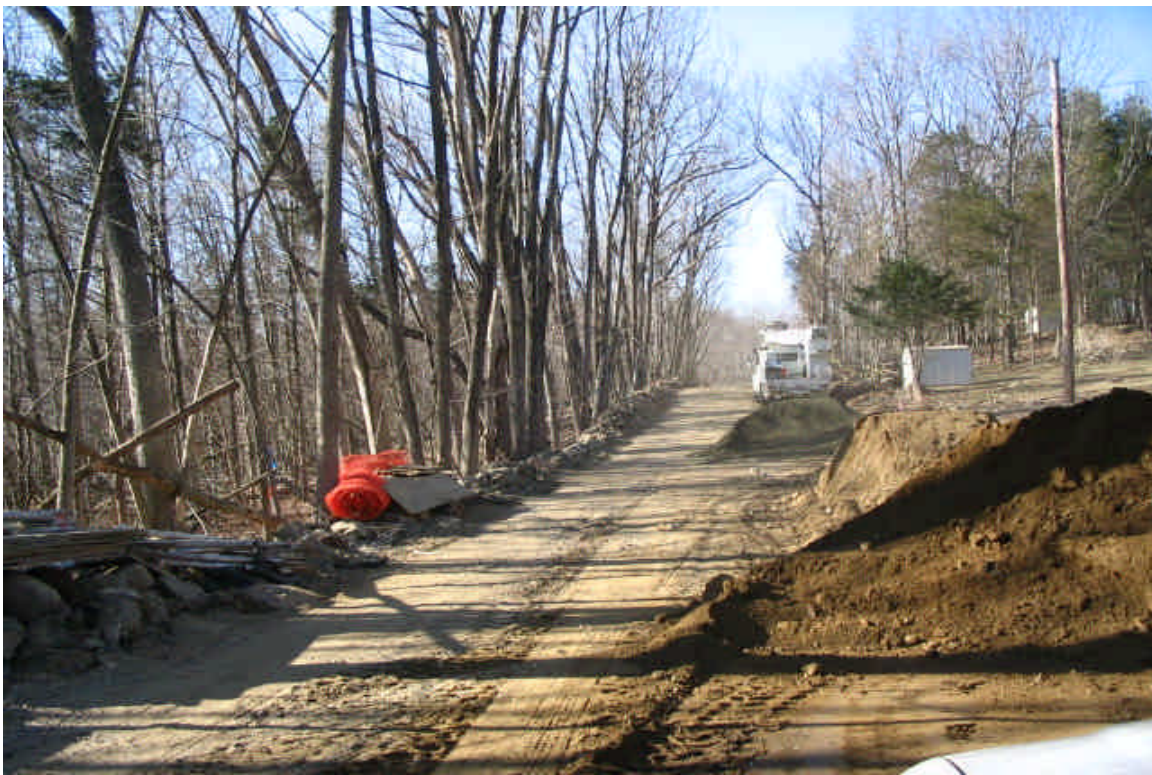
- The trenchwork for the 345kV project continues at the intersection of the access road and Diamond Hill Rd. Watch placement of materials along the silt fence and stone wall. 3/29/06.	- The stone wall helps to keep any sediment from the wetlands along the drive but sediment piles were noted. 3/9-3/29/06. Materials on the wall here also have to be removed. 3/29/06	-See 345kV report

**View of the access drive off Diamond Hill Road where activities associated with the 345kV project continue.  
Materials left along the stone wall should be removed. 3/29/06.**

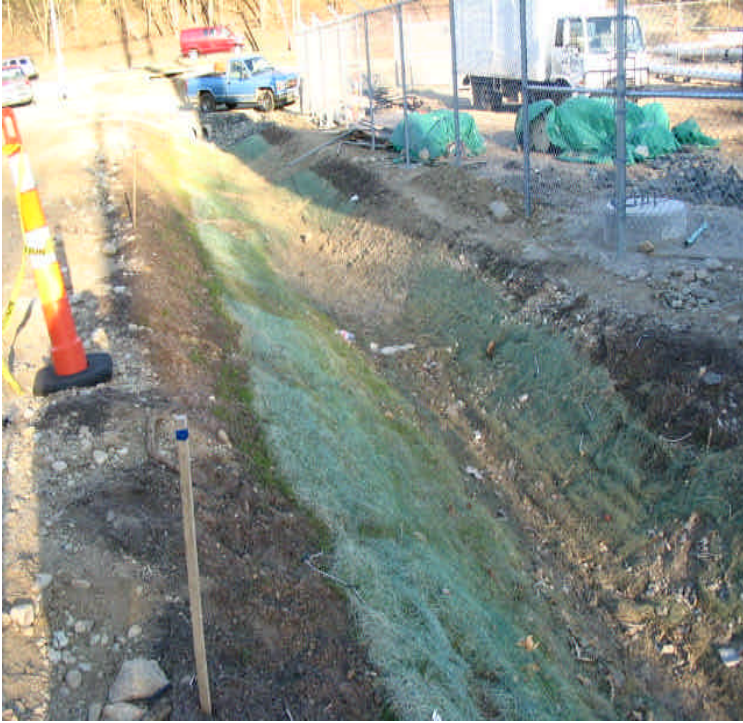
- <b>Norwalk Junction:</b> Sediment tracking did not appear to be an issue at this time. Sediment piles remain from the melted snow piles that were plowed into the swale during the last snow	-Continue to monitor Rt. 7 at the main access pad. 3/2-3/29/06.  - See erosion control section for more details on the snow/sediment.	-N/A

**Norwalk Junction:** Photo on the left shows a view of the sediment within the swale adjacent to the station pad. Photo on the right shows the old culvert that remains near the perimeter fence. It should either be removed or covered with haybales. 3/29/06.

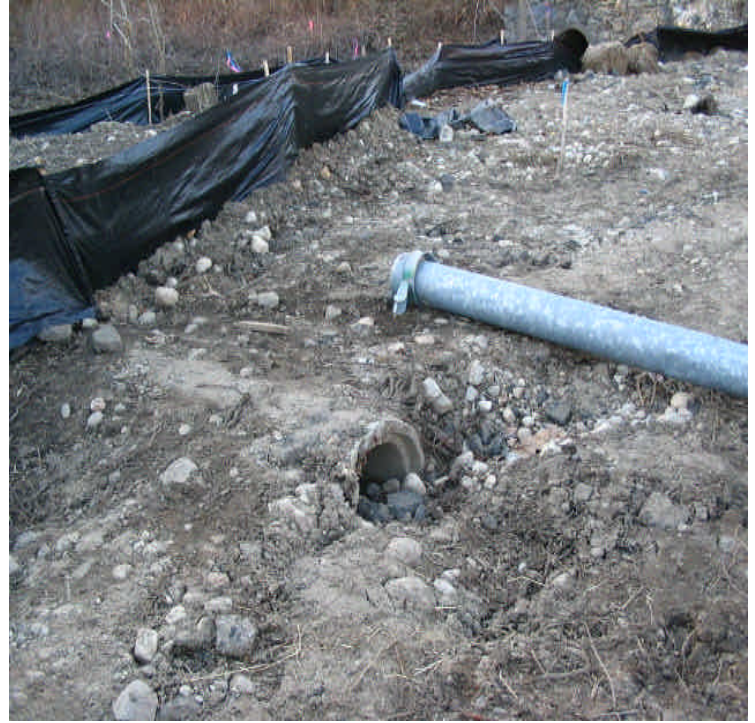
Areas of Inspection	Observation	Recommended Action	Corrected Actions
Erosion and Sediment Controls continued	<p>-The old culvert near the silt fence and the river was observed. It still shows evidence of occasional flow, including sediment from the disturbed soil at the site. 3/15-3/29/06</p> <p>-The wetland area outside the silt fence adjacent to the river shows some accumulated sediment 3/8-3/29/06.</p> <p>- Silt fence also may need repair in this location. 3/29/06</p> <p>- Sediment from previously plowed snow piles remained directly in and along the swale. This introduces more potential for turbidity. 2/16-3/29/06.</p> <p>- Erosive gullies remain in a number of locations along the lower drainage swale due to site run-off, resulting in further sedimentation to the swale. 12/30-3/29/06. Haybales remained in the inlets. 2/2-3/29/06.</p> <p>-The riprap swale remains to the Norwalk River for dewatering from the well points. 2/23-3/29/06.</p>	<p>- The culvert needs to have haybales installed if it is going to remain in place. Otherwise it should be removed/or the connection cut, completely 3/15-3/29/06</p> <p>- This area receives direct runoff from the site through the swale making water quality important. The adjacent site is disturbed resulting in this turbidity. 1/19-3/29/06.</p> <p>- Snow has melted but sediment could be removed from the swale. 3/8-3/29/06.</p> <p>- The erosion control matting on the swale likely needs to be extended up and over the top of slope to prevent further erosion until the growing season. 12/30-3/29/06.</p> <p>- Water was directly observed from the pipe and it remains crystal clear. 3/23-3/29/06</p> <p>- Be sure to restore this outlet area when work is complete. 2/16-3/29/06.</p>	-N/A until work is complete.

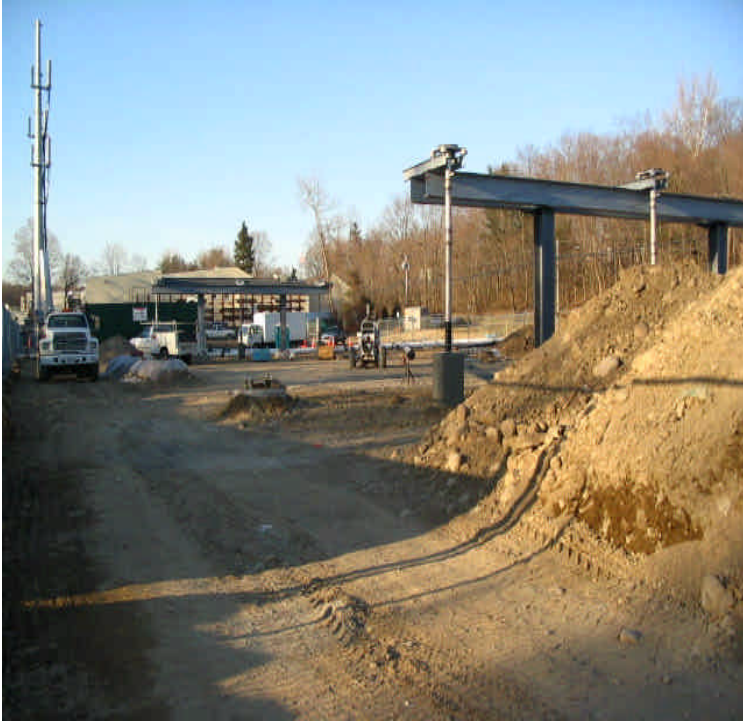
Photo on the left shows an overall view of the station yard where excavation continues but some backfill and grading had occurred. Photo on the right shows activity and stockpiles resulting from 345kV crews trenching into the station yard. 3/29/06.
